Report: BALLARD, PAT REPORT

Inspection Address: 3237 Calle Celestial, Santa Fe, NM 87508

Date: August 25, 2009

Confidential Inspection Report
3237 Calle Celestial
Santa Fe, NM 87508

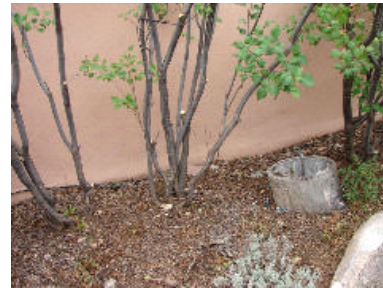
GRADING:

Fill in any low spots next to the structure and make sure that there is a 1/4 inch to the foot slope away from the structure.

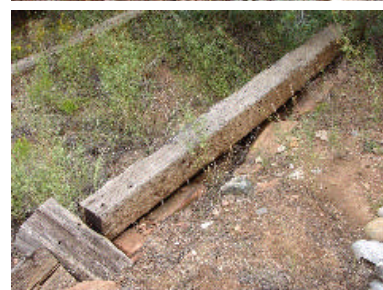
RETAINING WALLS:

True retaining walls are engineered structures retaining earth, which, if they collapsed, would adversely affect the integrity of buildings, driveways, pools, or other improvements. We are not equipped to analyze such structures using mathematical and engineering tools. The structural retaining walls appear to have performed as intended and are in acceptable condition with the exception of north railroad tie walls. They have subsided and should be repaired.

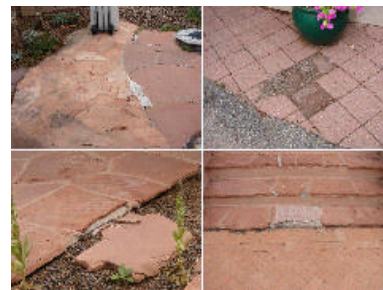
PATIOS:

Spalling of the surface of the concrete patio is probably due to freeze/thaw action and would be considered a cosmetic defect. Repair for a better appearance would be considered optional. Most repair techniques will prove to be unsatisfactory. Some of the brick at the entry has settled slightly.

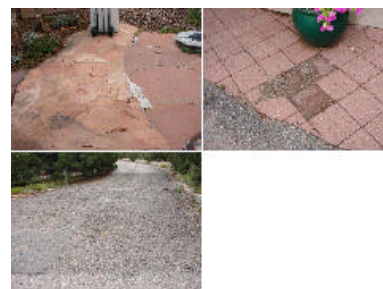
DRIVEWAYS:

The asphalt driveway has reached the stage where patching and sealing have been necessary, but is currently in acceptable condition. Resealing the surface is recommend in the course of routine property maintenance.

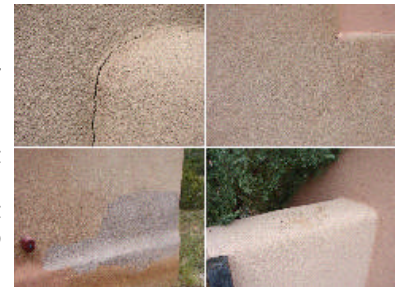
FACING/COATING TYPE(S):

Main house: Acrylic (Synthetic) Stucco. This is the preferred product for this climate, as it expands and contracts during heat swings, and allows water vapor out of the walls while repelling moisture from the wall interiors. Studio: Conventional Stucco. Conventional stucco is an older product which is not waterproof. It tends to crack and spall (peel). There is no long term cure for this condition except to recoat the walls with an acrylic, synthetic stucco product.

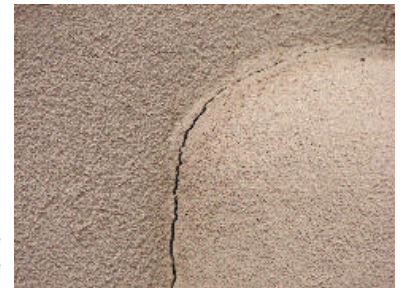
STUCCO:

Main house: The good condition of the exterior wall stucco, including a noticeable lack of superficial cracking, indicates both proper original installation and a stable structure and building site. Studio: The good condition of the exterior stucco indicates both proper original installation and a stable structure and building site. The minor hairline cracking is usually a result of shrinkage of materials and should not be considered a structural deficiency. If the cracks becomes larger over time, they should be patched and sealed as part of routine maintenance. Flexible patching materials are recommend rather than rigid cementitious patching compounds. If acrylic stucco is present try to keep all minor cracks patched with acrylic emulsion. There are area(s) where plastered walls were not covered by a color coat.

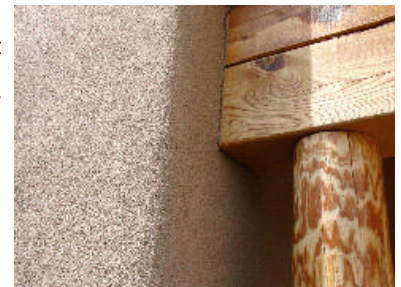
FLASHING & TRIM:

The exterior trim appears to be properly installed and in acceptable condition. There are openings at sections, seams and joints of the trim. We recommend caulking and sealing to help prevent air and pest infiltration, moisture entry and subsequent damage. We recommend that urethane caulk be used rather than silicone, butyl or latex.

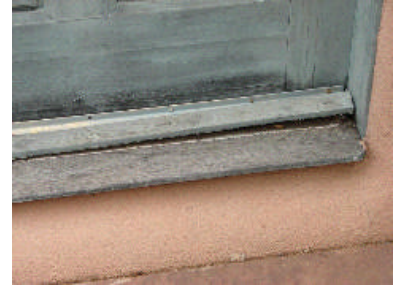
EXTERIOR DOORS:

The exterior doors appear to be properly installed and in acceptable condition. One studio sill has come loose. Reattach it.

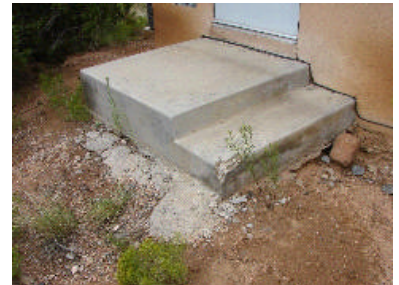
STEPS:

Cosmetic grout damage was noted. Repair as needed. The rear studio stairs are spalling and undercut.

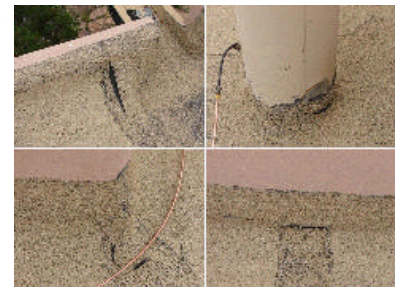
FLASHINGS: Separations and lifting membrane material were noted at several locations at the roof perimeter. Repair as needed.

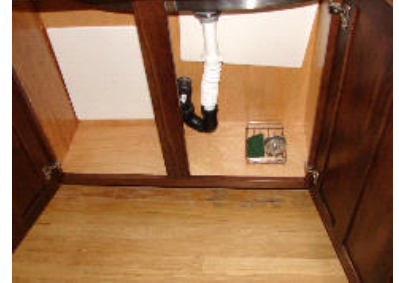
LAUNDRY TUB/ WET BAR SINK: There are signs of leakage under the kitchen bar sink. Investigate the source and repair as needed, if not already remedied.

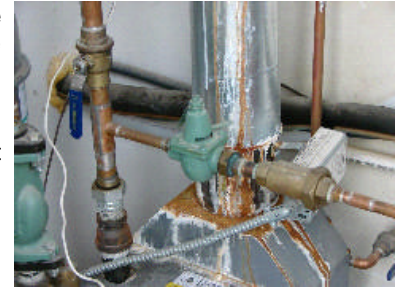
VENTING:

The furnace vent pipe is rusted and may require replacement in the near future. This should be routinely monitored for signs of further deterioration and replaced when necessary. These units should not be turned off as flue gases condense in the flue and may cause oxidation in the boiler itself. Contact a how water heating specialist.
