Report: BALLARD, PAT REPORT

Inspection Address: 3237 Calle Celestial, Santa Fe, NM 87508

Date: August 25, 2009

Confidential Inspection Report
3237 Calle Celestial
Santa Fe, NM 87508

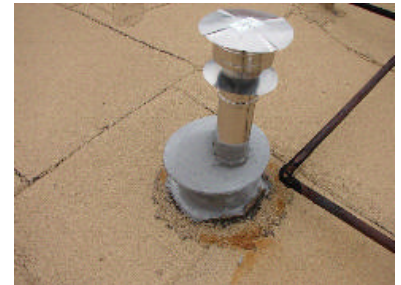
FLASHINGS: Separations and lifting membrane material were noted at several locations at the roof perimeter. Repair as needed.
